Analog Cameras

I See A White Halo On Some of My Cameras At Night

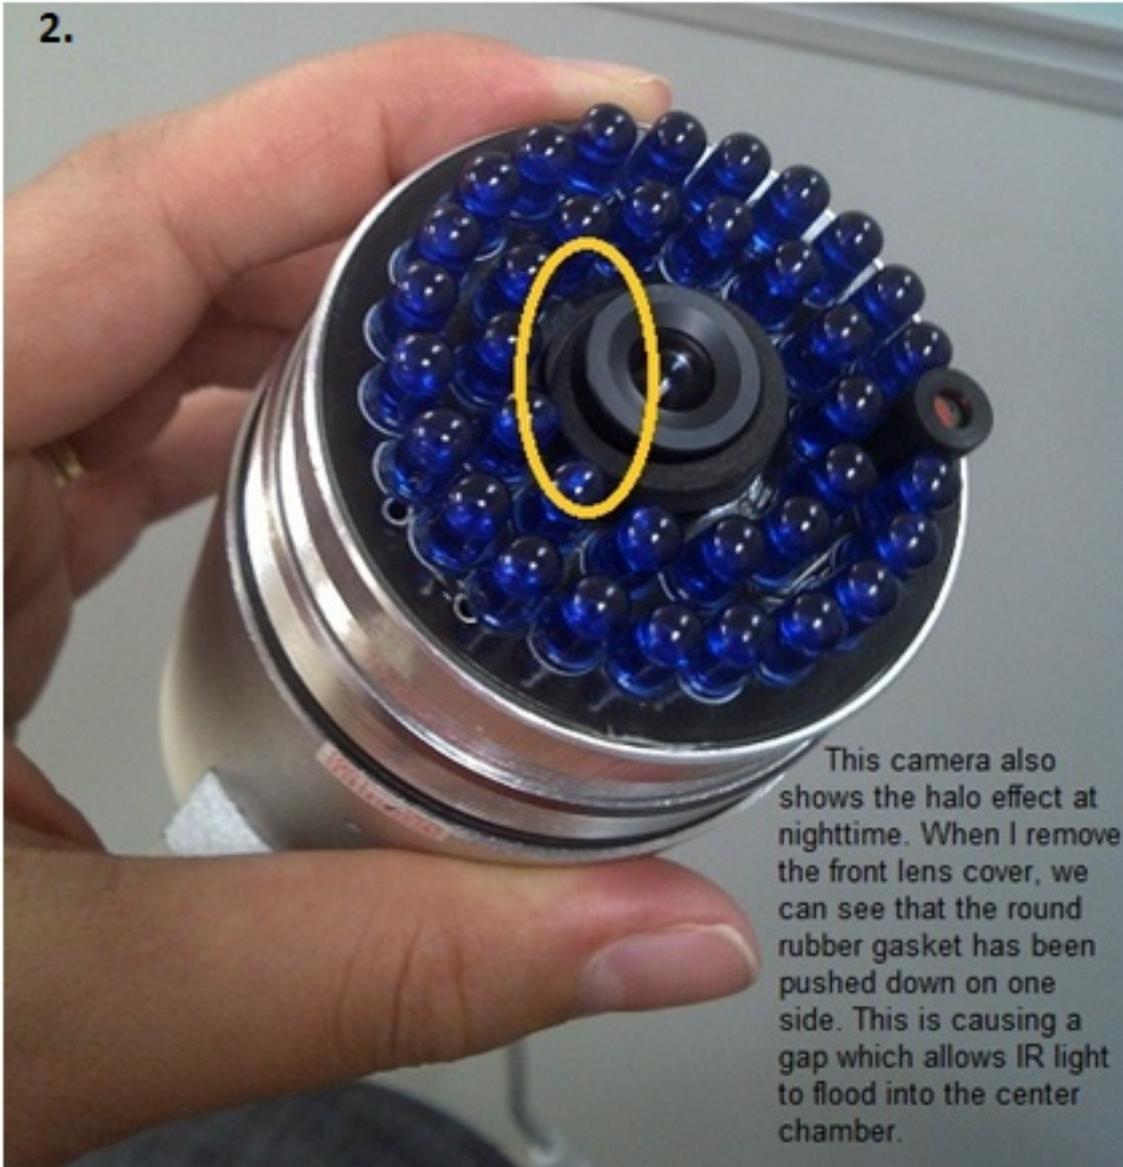
2.

This camera also shows the halo effect at nighttime. When I remove the front lens cover, we can see that the round rubber gasket has been pushed down on one side. This is causing a gap which allows IR light to flood into the center chamber.

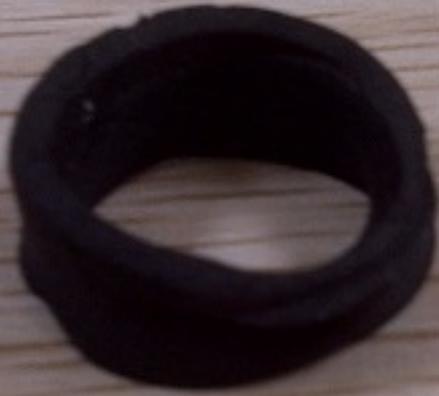
3.

Please remove the small round rubber gasket from the camera. The gasket in this picture is still warped on one side.

Once the gasket is removed, please try to work out the warp and flatten the gasket as much as possible so that all sides stand equally tall when the gasket is set on its round side.
